Sinexcel SVG Application in Press Machine

Shenzhen Sinexcel Electric Co., Ltd

Date: 2017/3/24

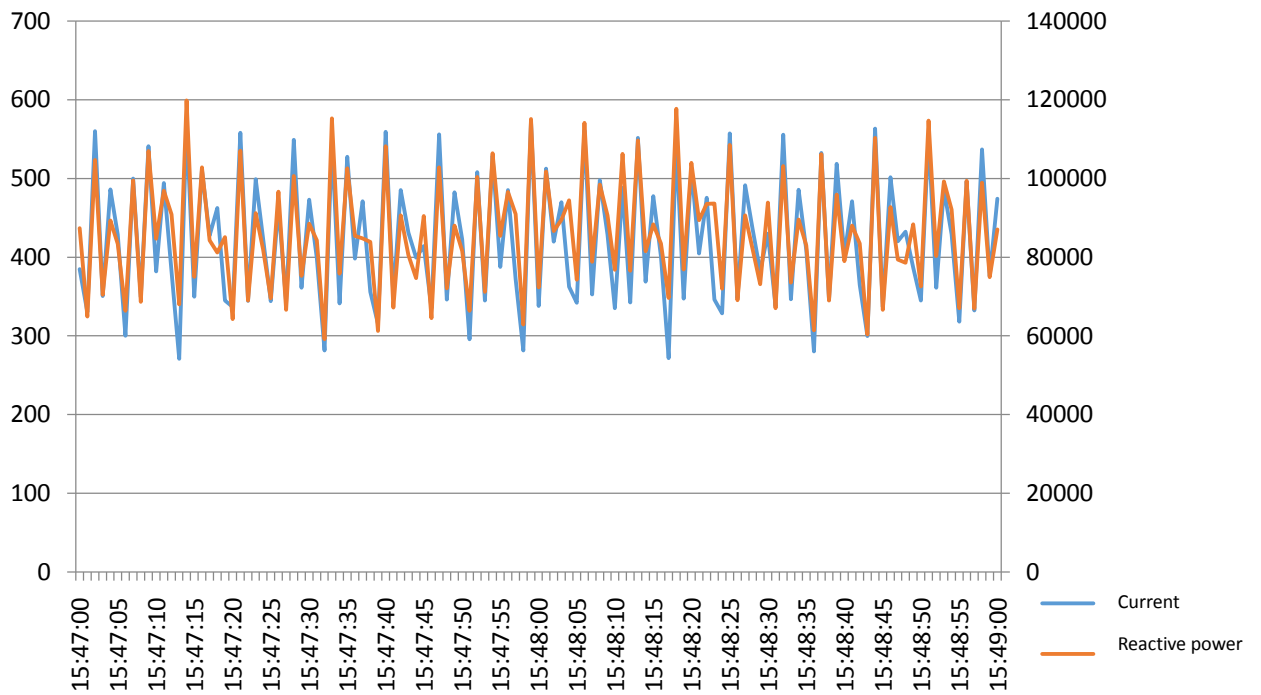
Figure 1-1 reactive power and current tendency chart

1. During the press machine working, the loads reactive power changes so fast that capacitor banks couldn't catch up with the speed and changing rate. From this tendency chart of reactive power and current, you can found they change so many times in 2 seconds. We have to use Fluke or AI to catch up these data and record, import them into table and chart.

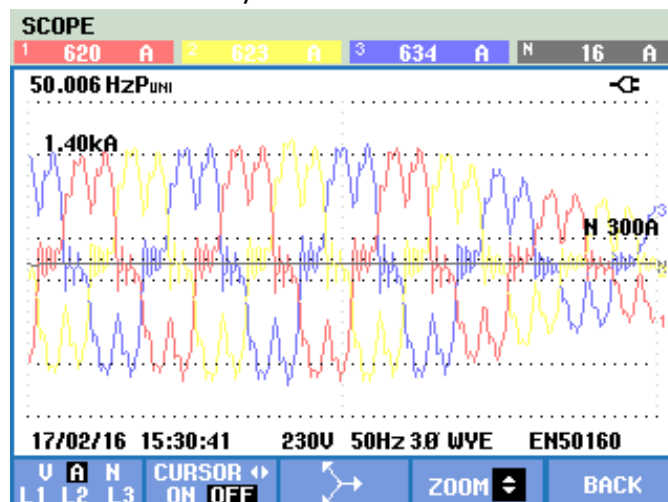
Figure 2-1 current waveform

2. Press machines can generate a lot of harmonic which can seriously impact capacitor banks. There have high harmonic current with 5/7/11/13/17 orders and the THDi up to 45.3% and THDu 5.8% in the system.

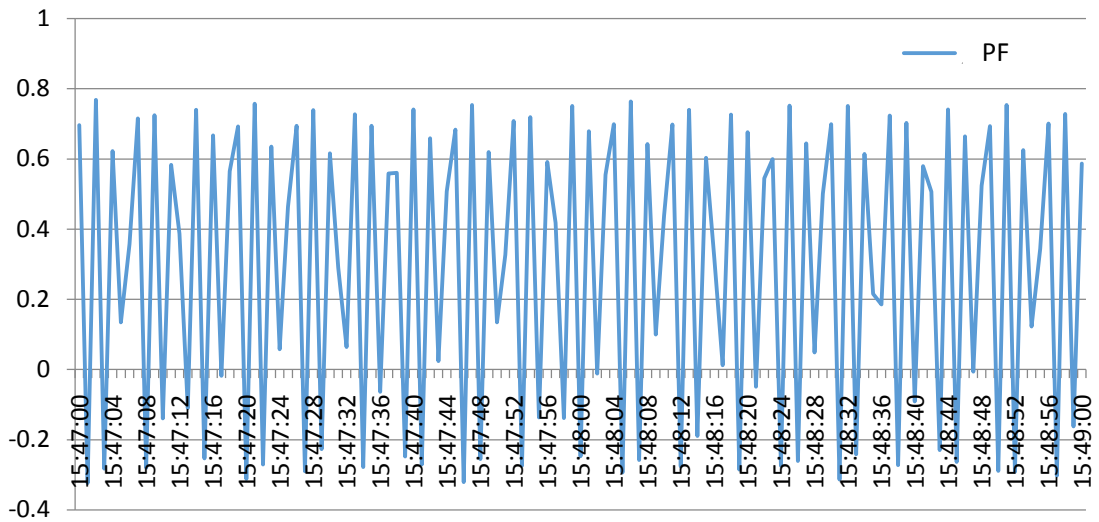
Figure 3-1 System PF

- Press machine have poor PF, one hand is own can generate reactive power, another hand is the harmonic current also as reactive power can occupy the whole system apparent power.

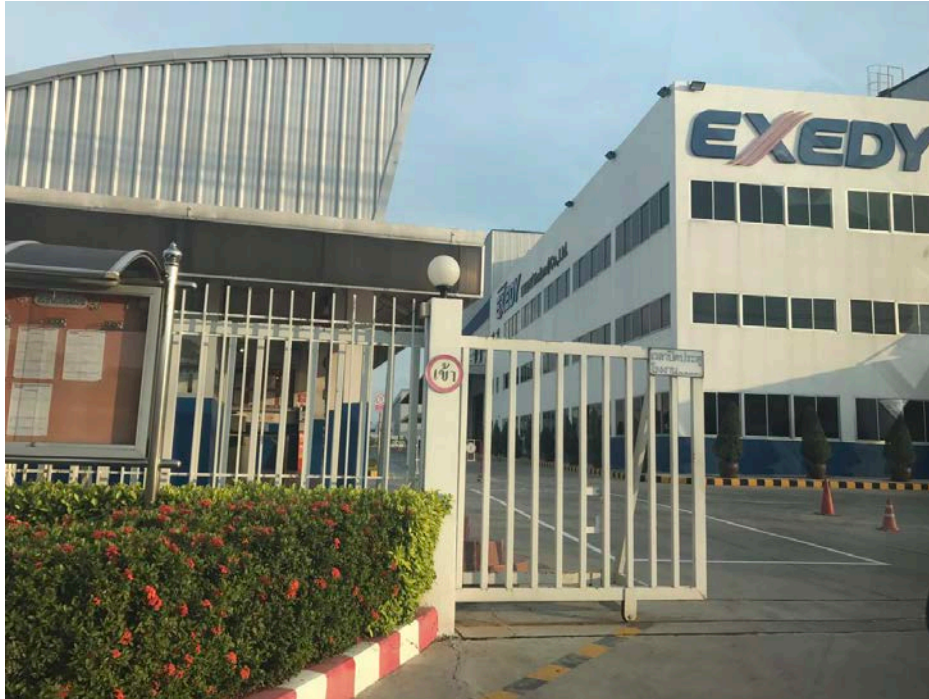
There are many press machines for manufacturing car parts in the factory. The working speed and frequency are both very high, so the high changing speed of reactive power with the high THDi will cause bad power quality problem. There is large content of reactive power in the power system, which leads to that the normal manufacture can't proceed and will be charged by the grid company.

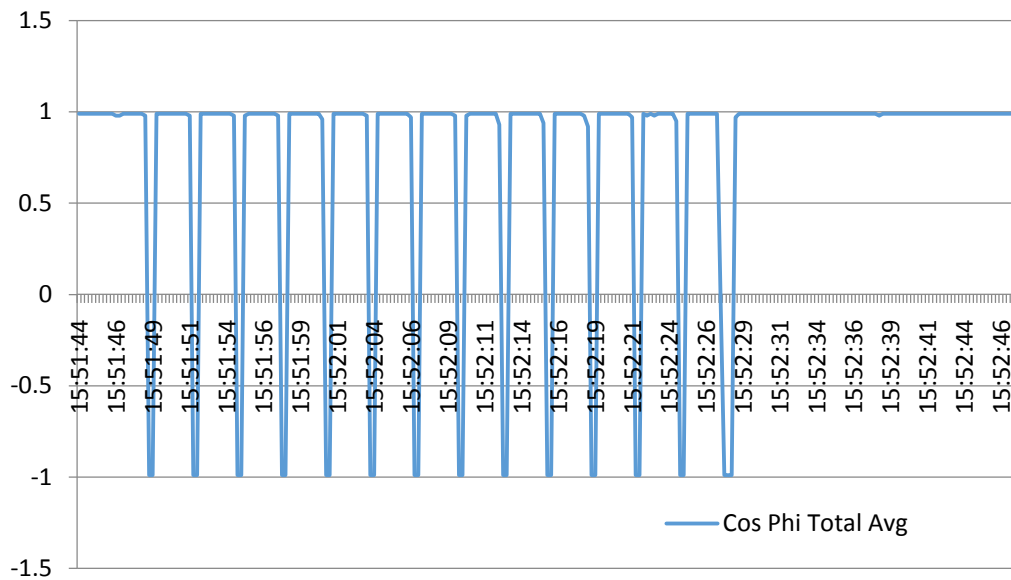
Figure 5-2 the system Cos Phi after compensation

After installation, every the Cos Phi closed with 1 like Figure 5-2, sometimes the PF could up to 0.99 when press machine working under low loads like Figure 5-3 and Figure 5-4.

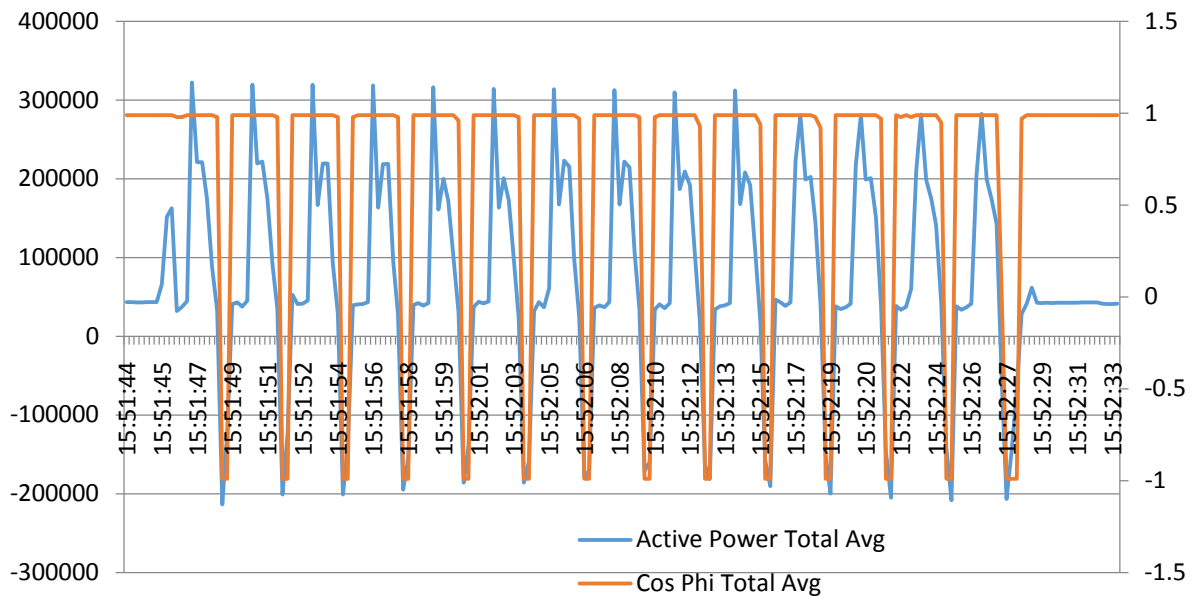
Why happen Cos Phi appearing -1, it is because active power appear negative value.

$$\cos \Phi = \frac{\text{active power}}{\text{aparent power}} \text{-----(formula 6-1)}$$
